CALSPAN ON-SITE INADVERTENT AIR BAG DEPLOYMENT INVESTIGATION

CALSPAN CASE NO. 92-8

VEHICLE - 1990 PLYMOUTH ACCLAIM

LOCATION - [REDACTED], GA

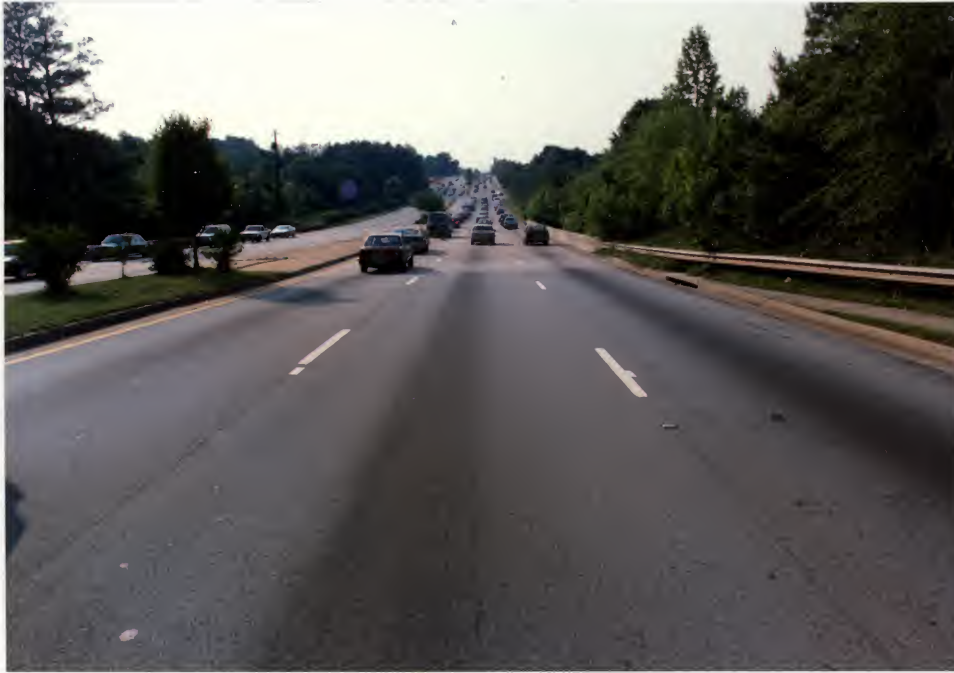
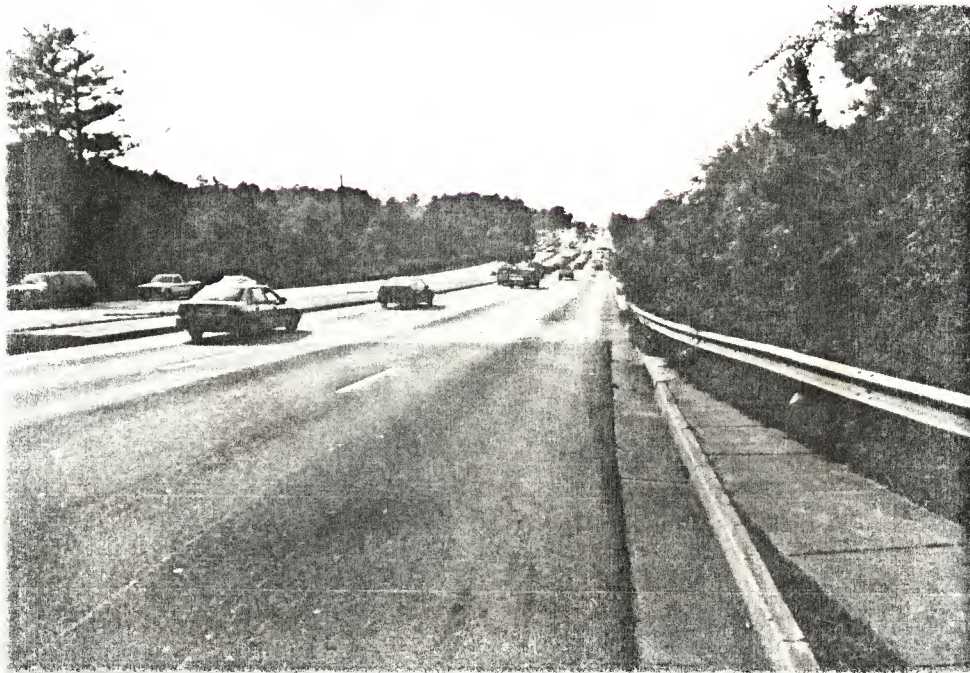
Path Of Travel Of The 1990 Plymouth Acclaim.

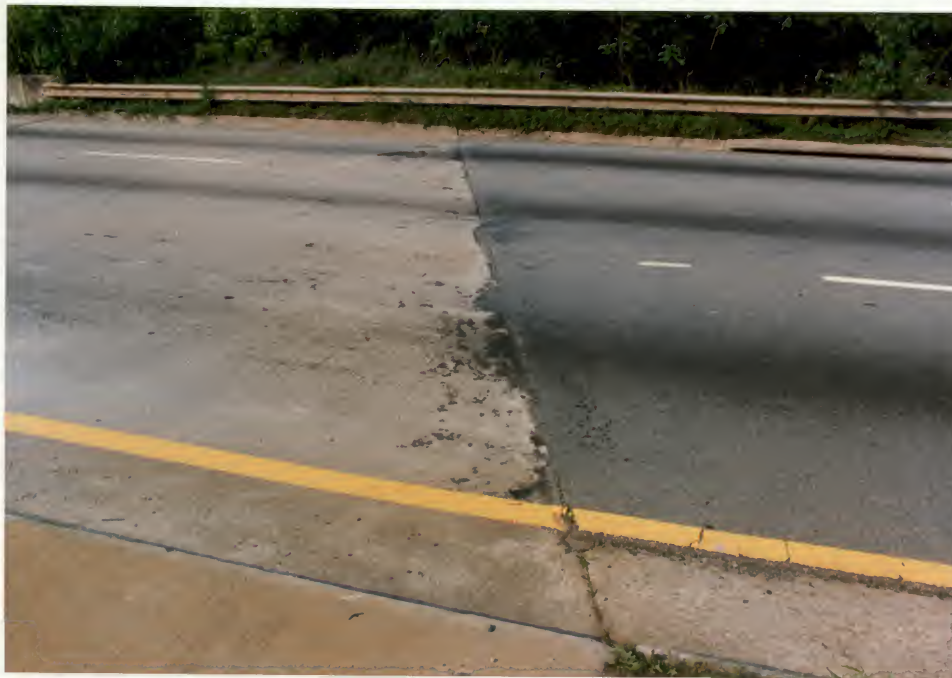
Transition Point From The Asphalt Road Surface To The Concrete Bridge Surface.

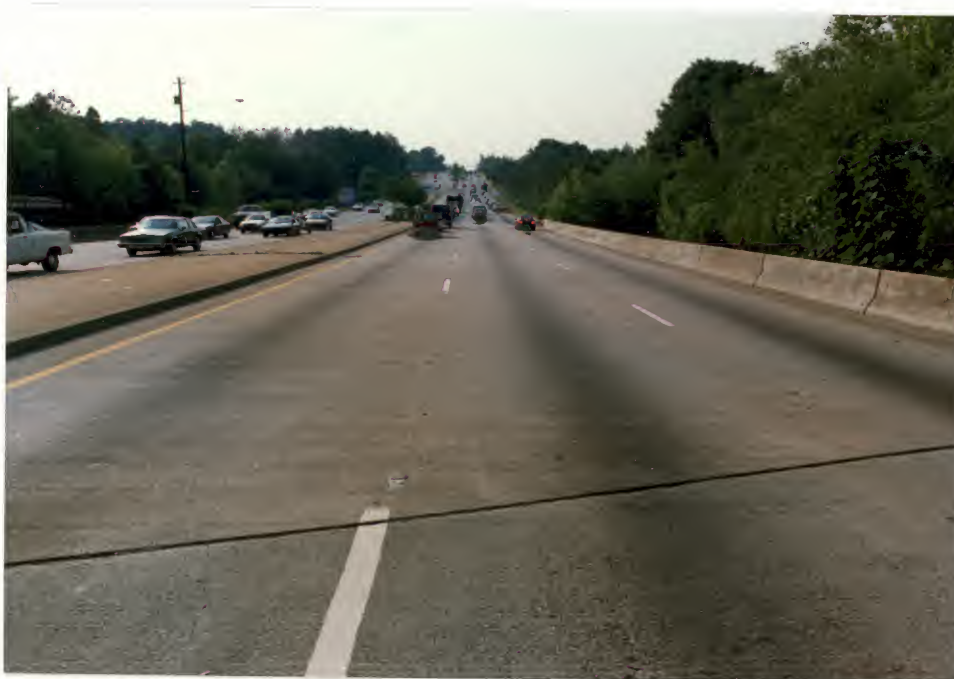
Vehicle's Continued Path Of Travel.

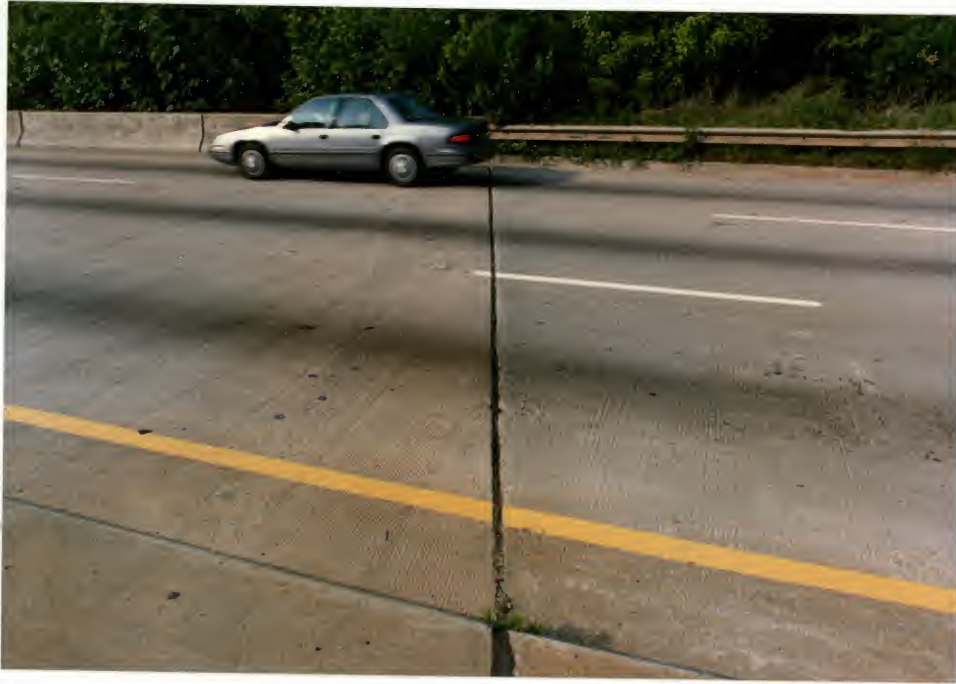
2" Wide Pour Joint Near Beginning Of Bridge.

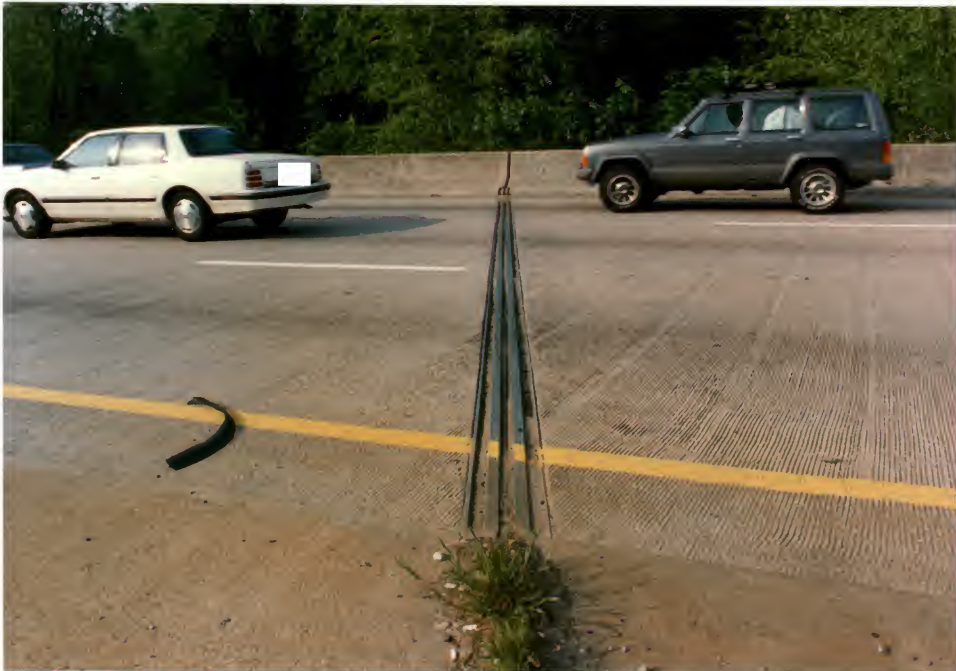
Expansion Joint At The Mid Bridge Area.

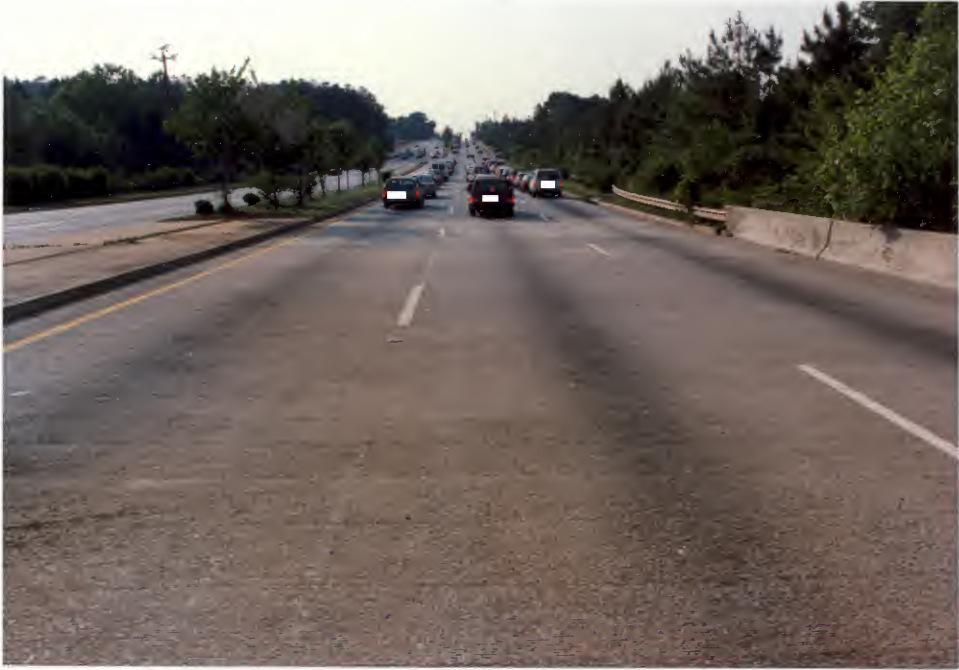
Vehicle's Trajectory To The Area Of The Alleged Inadvertent Deployment.

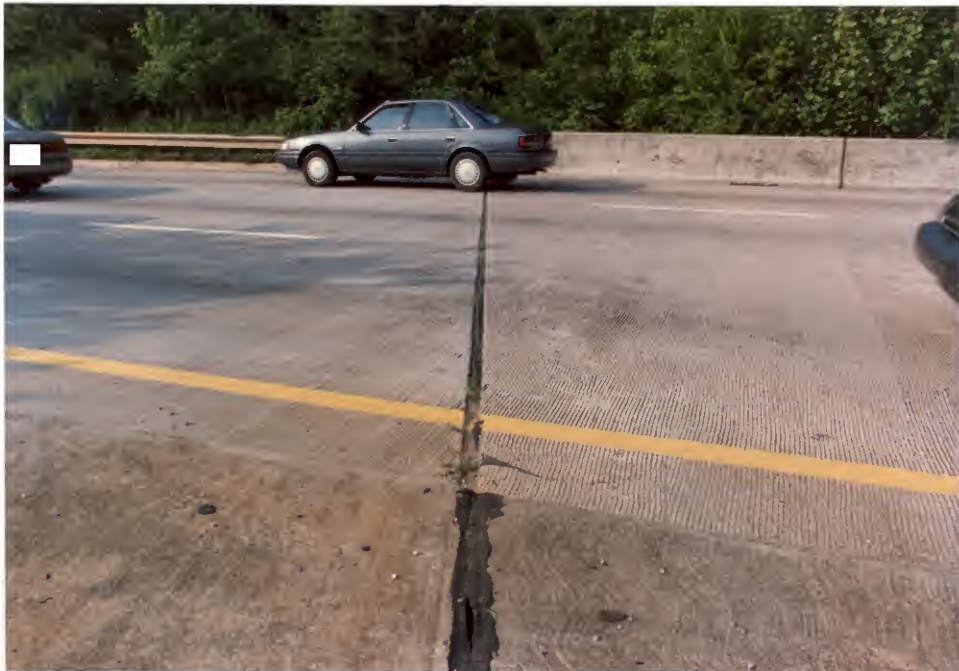
2" Wide Pour Joint In Concrete Surface Located 30' From End of Bridge.

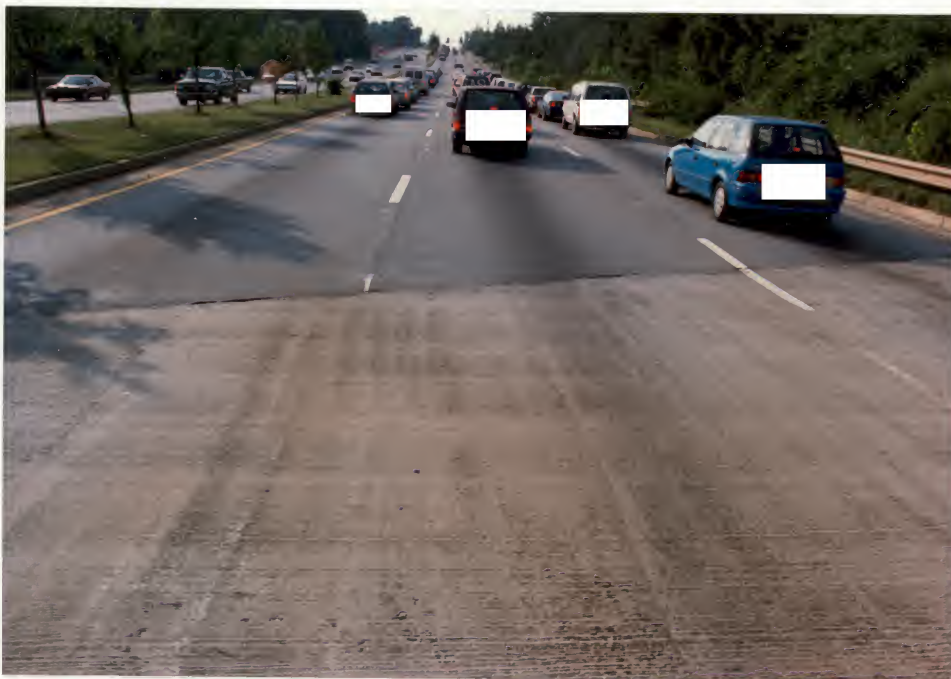
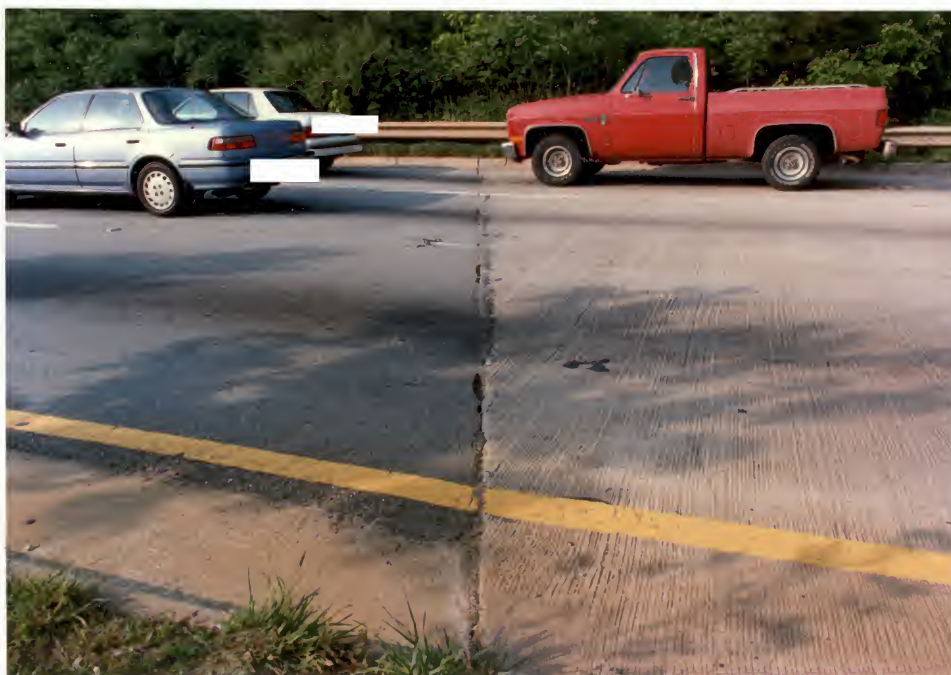
Transition Point From The Concrete Bridge Surface To The Asphalt Road Surface.

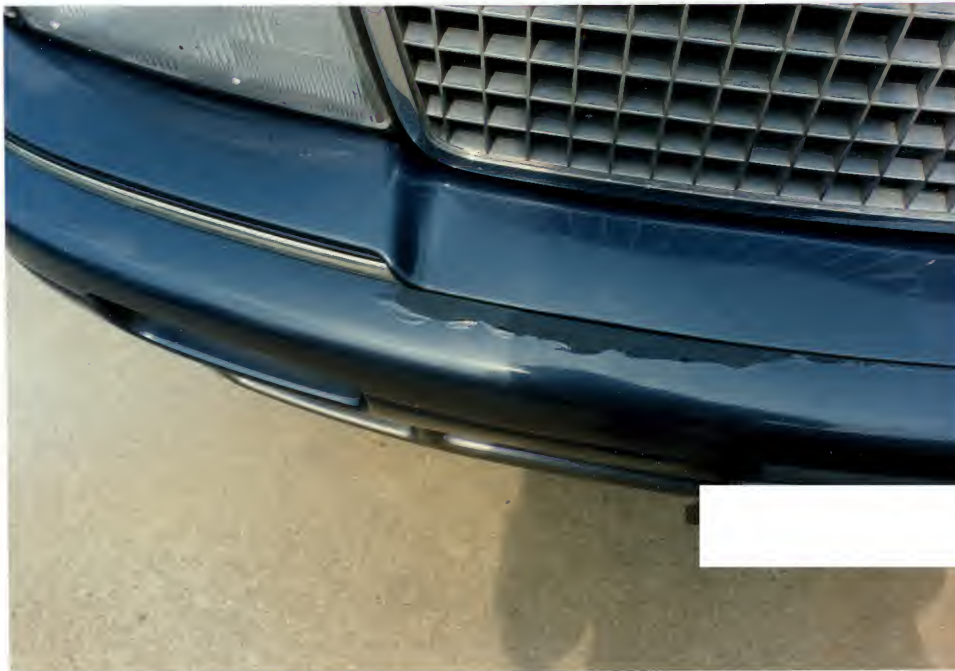
Paint Peeling From The Top Surface (Horizontal) Of The Right Front Bumper Facia.

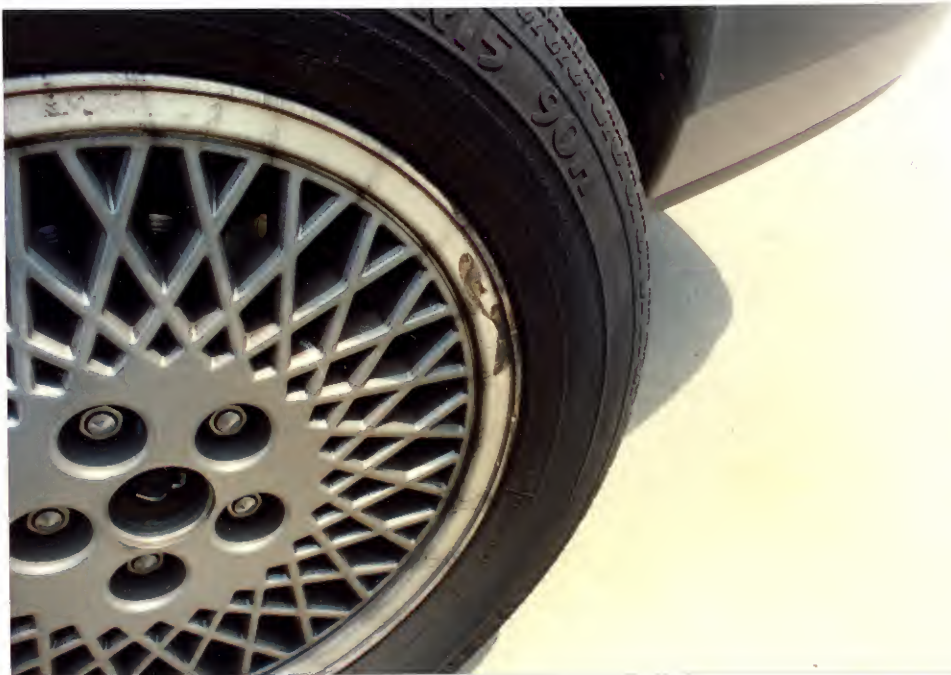
Dealer Documented Damage To The Right Front Wheel.

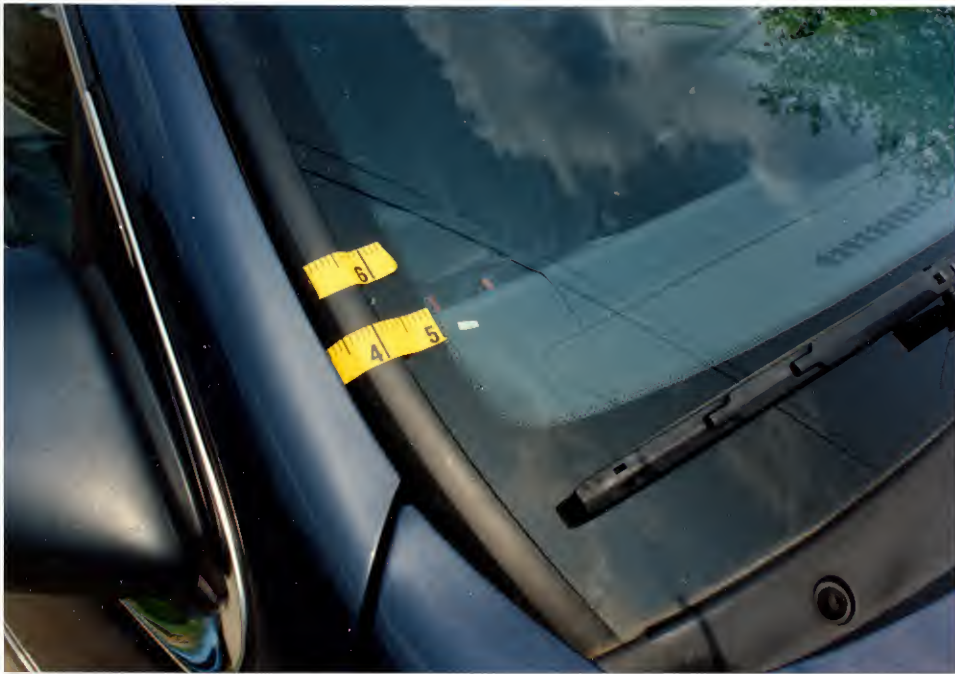
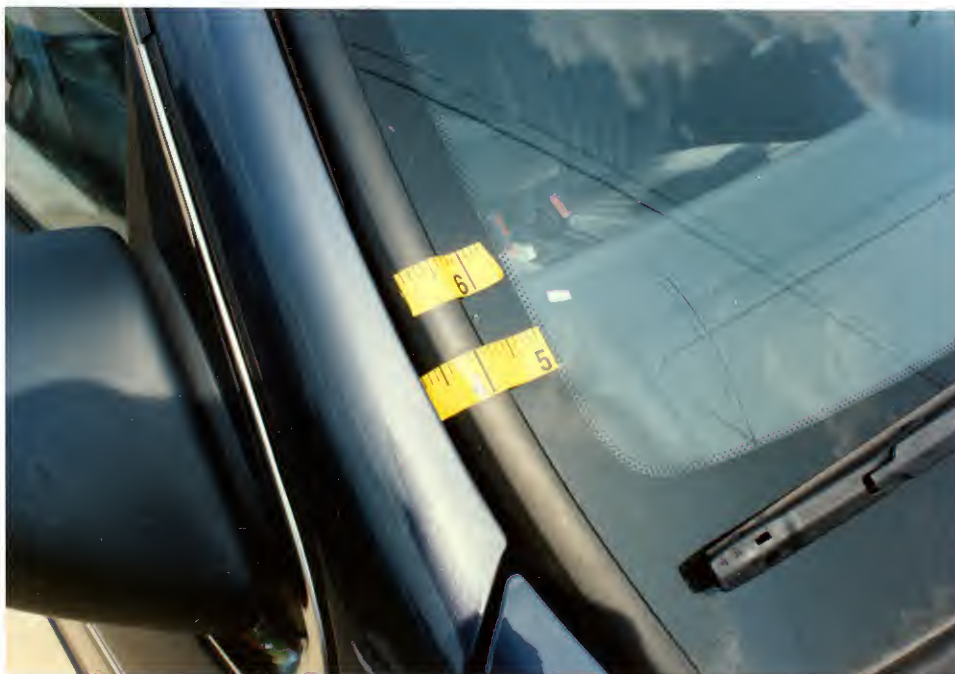
Crack To The Outer Pane Of The Windshield At The Lower Right Corner,
Crack Appears To Originate From A Stone Chip Located 0.125" Inboard
Of The Right A-Pillar.

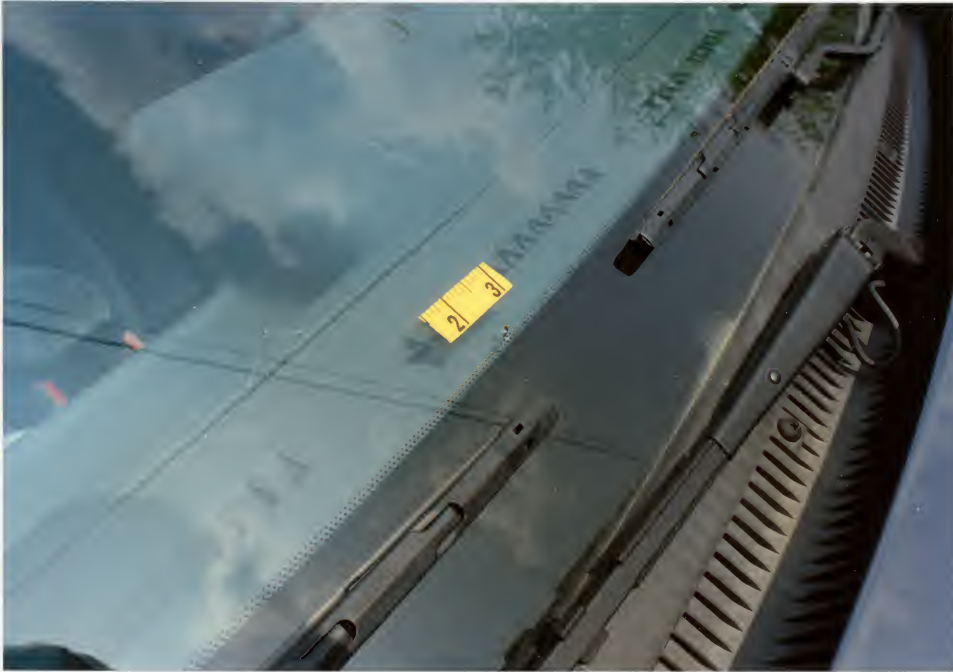
Another Stone Chip Near The Lower Center Portion Of The Windshield.

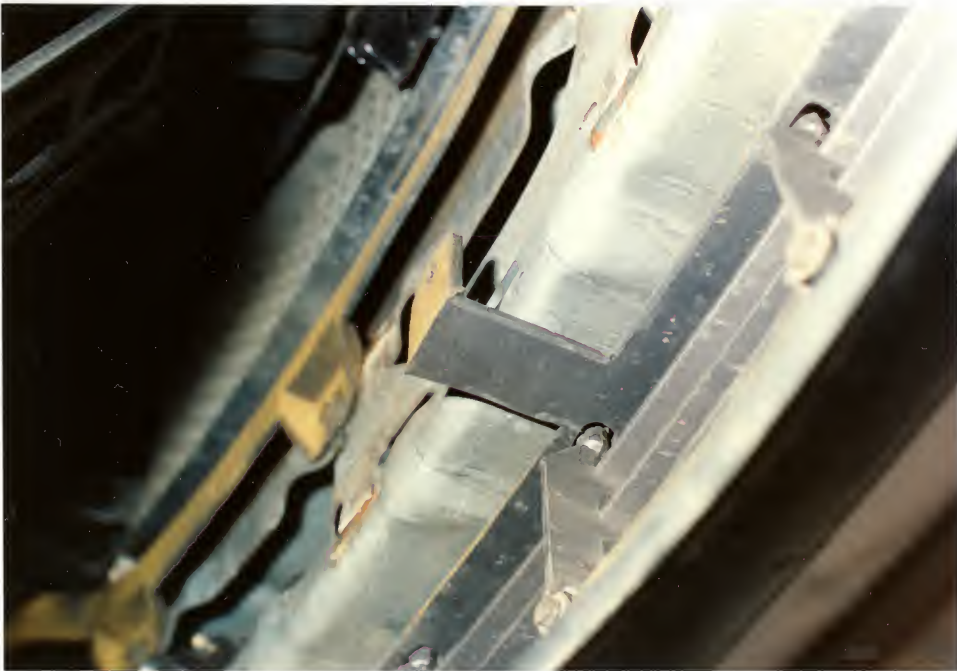
Center Support Bracket For The Lower Bumper Facia
(Push Plug Missing, Bracket Not Attached To Bumper Rebar).

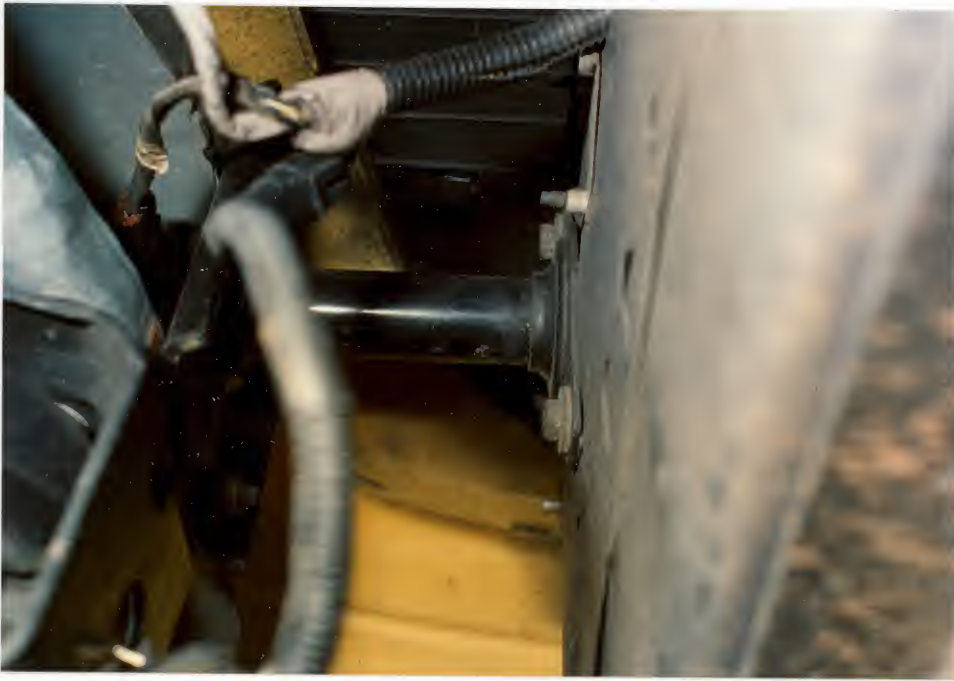
Right Front Bumper Energy Absorbing Device (EAD); 7/16" Of Compression And Return.

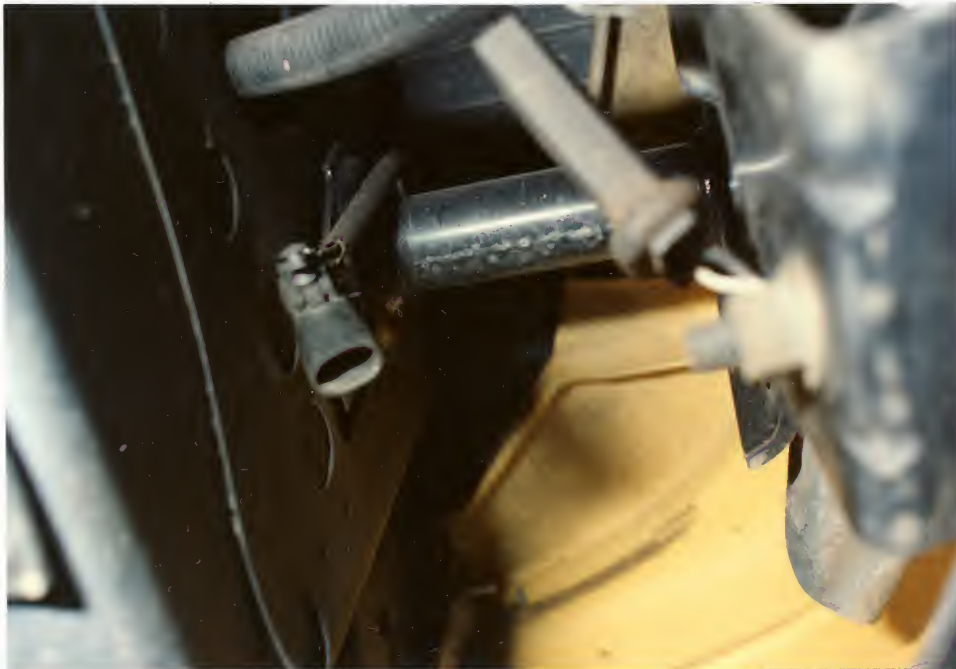
Left Front Bumper EAD; 1/4" Of Compression And Return.

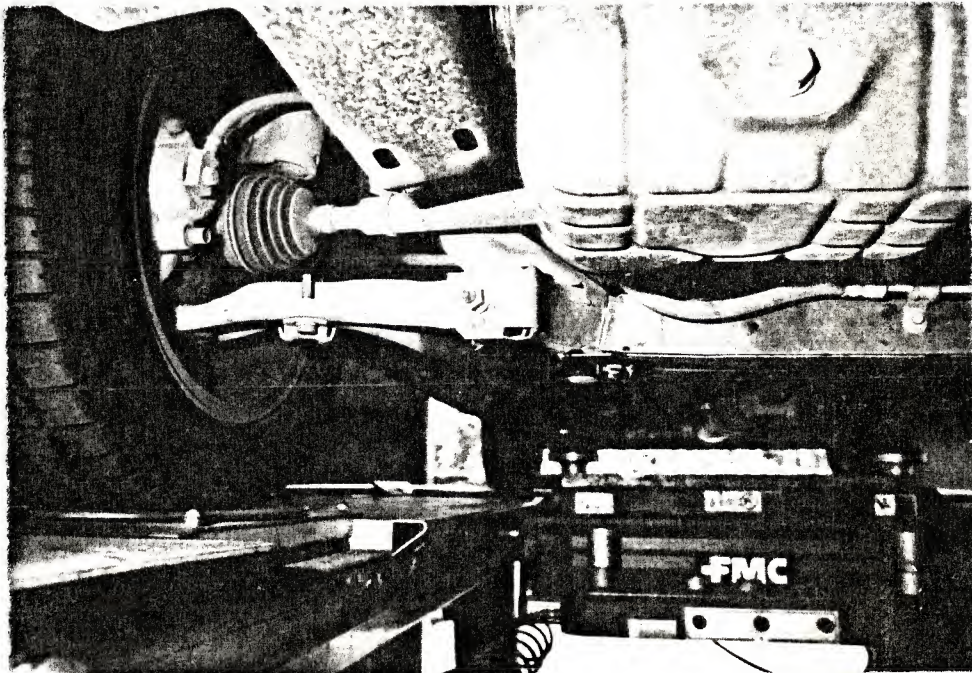
Tissue And Hair
On Crossmember

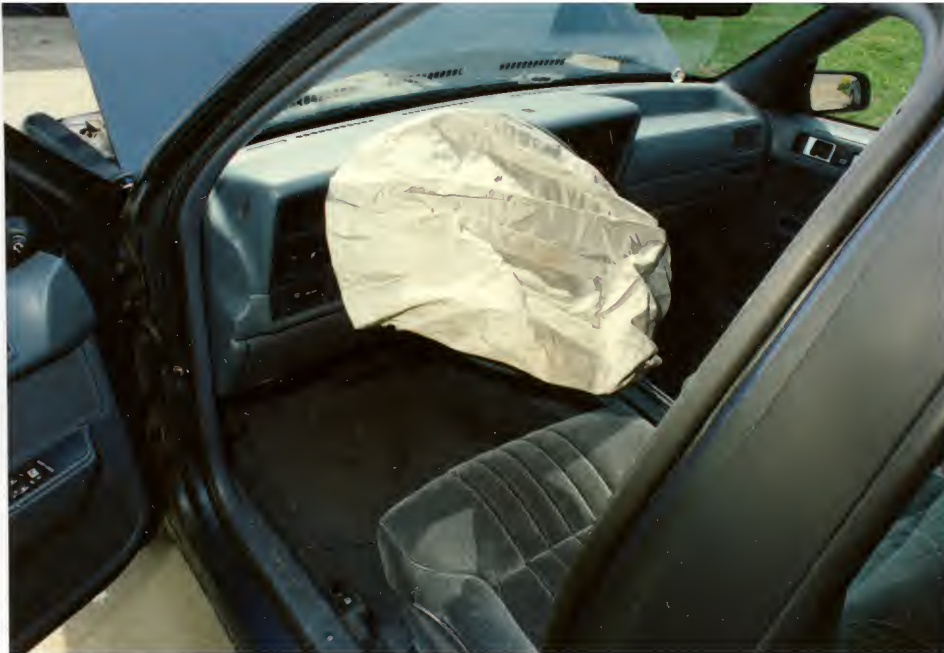
The air bag deployed properly from the module assembly. The module cover tore open in a H-configuration at the designated tear points. The bag was not damaged and was found neatly folded into the module cover. The air bag was identified by the following number sequence:

Deployed Driver's Air Bag.

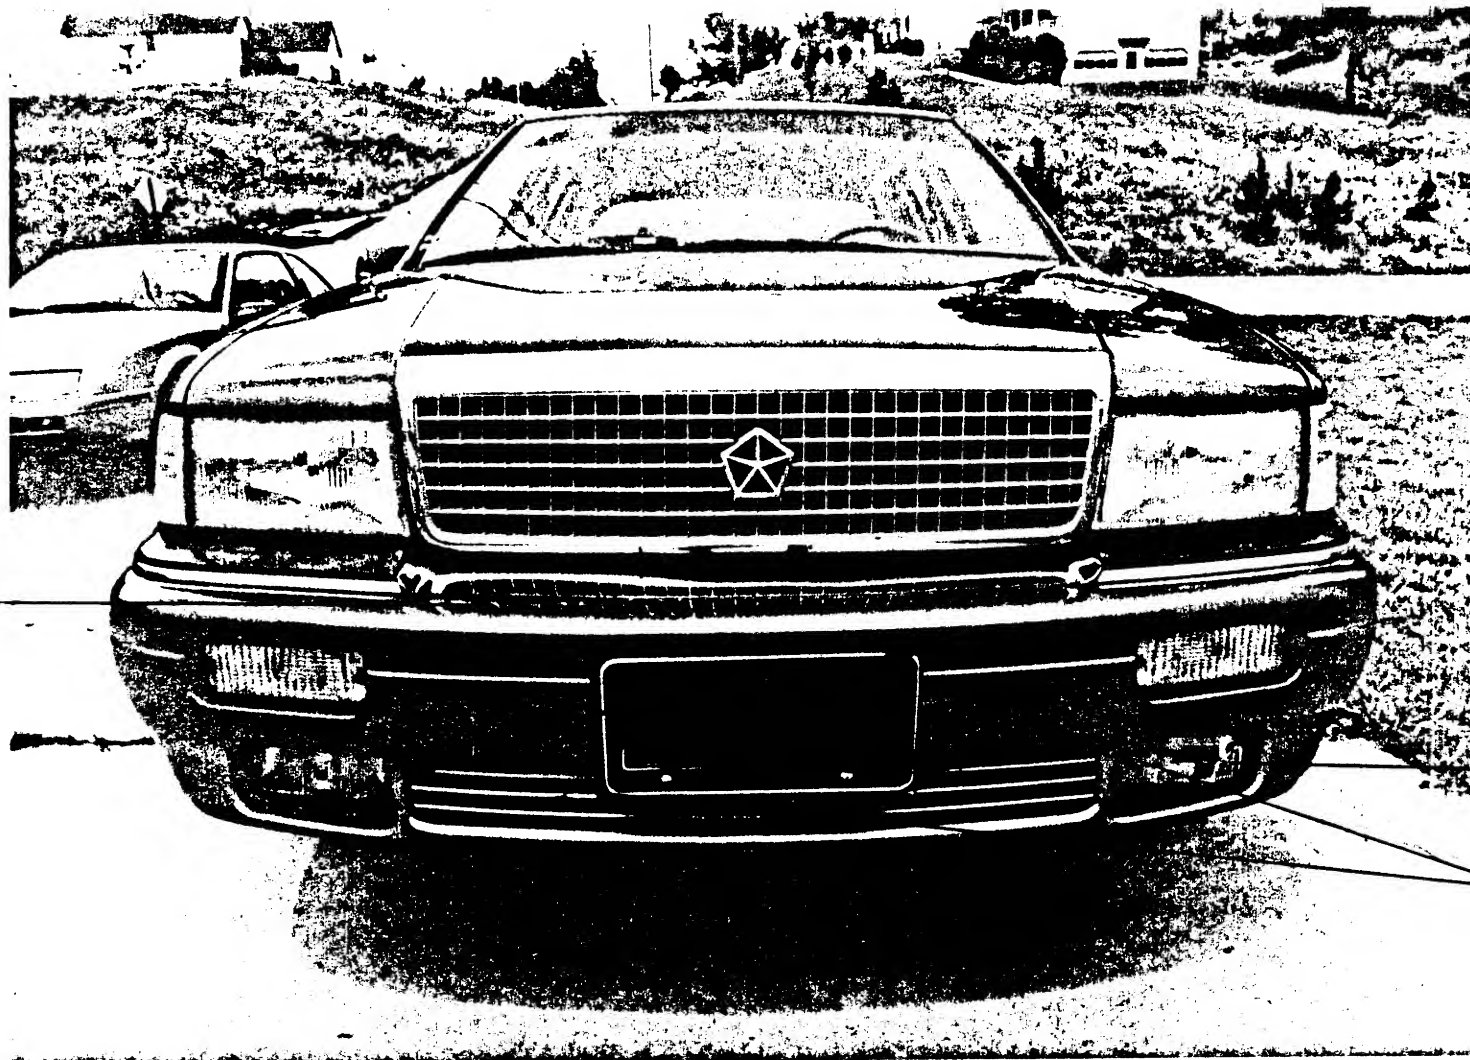
Paint peeling
from top of
bumper facia

Driving lamp lens
cracked

Paint chipped

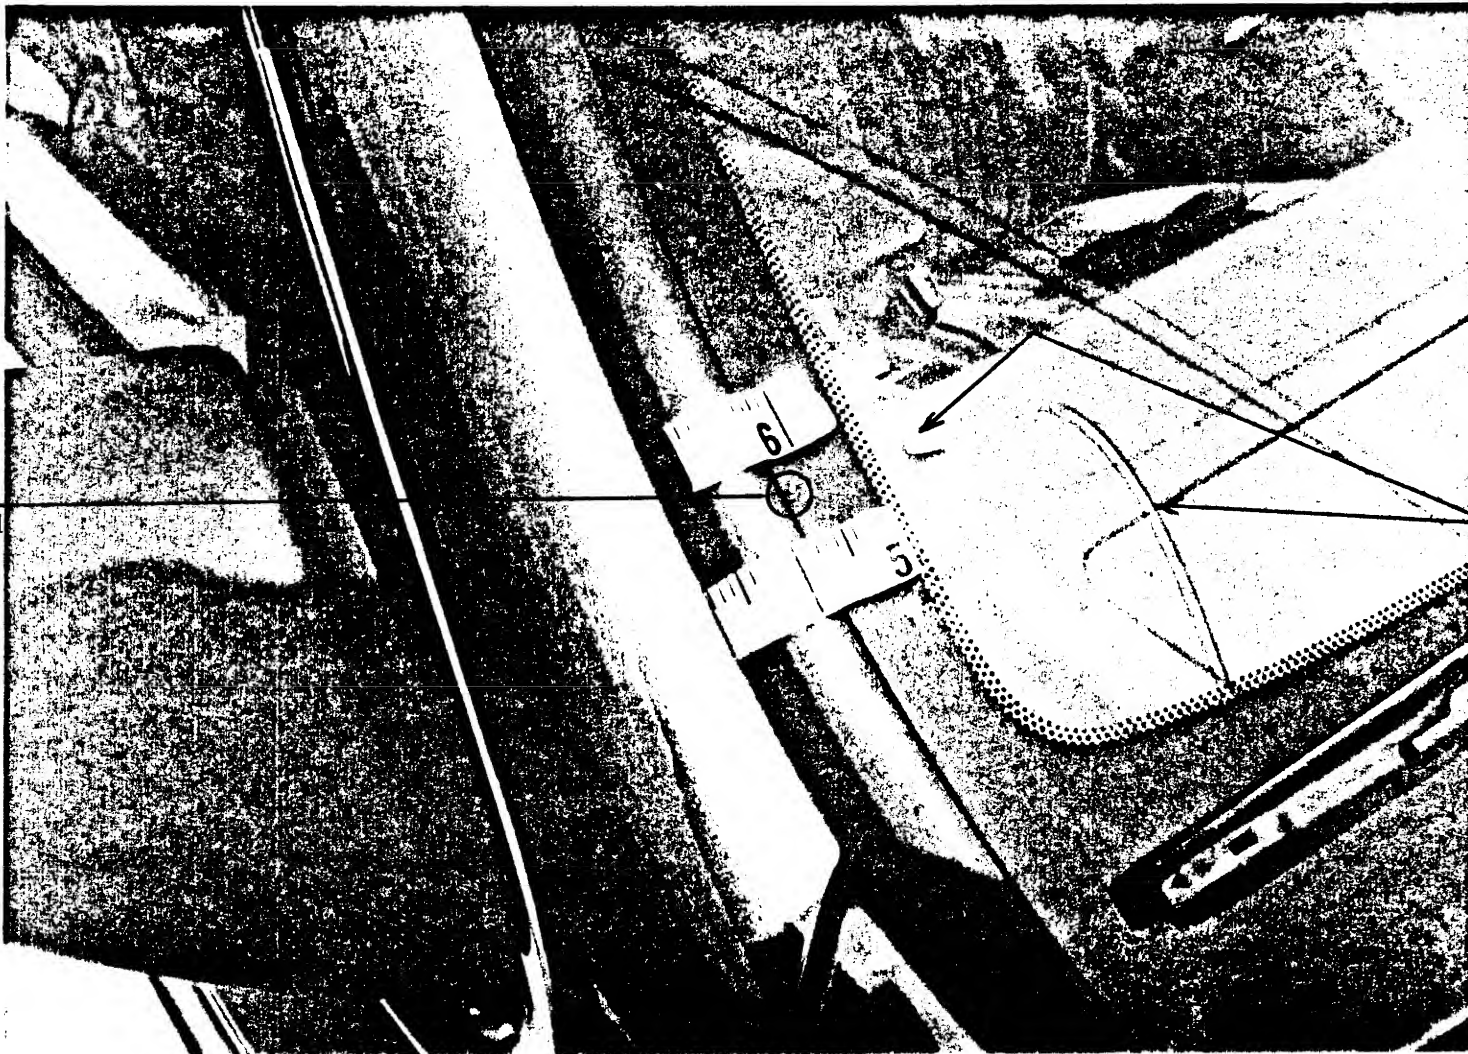
Apparent stone
chip to windshield

Crack to
outer pane of
glass, orig-
inates at chi

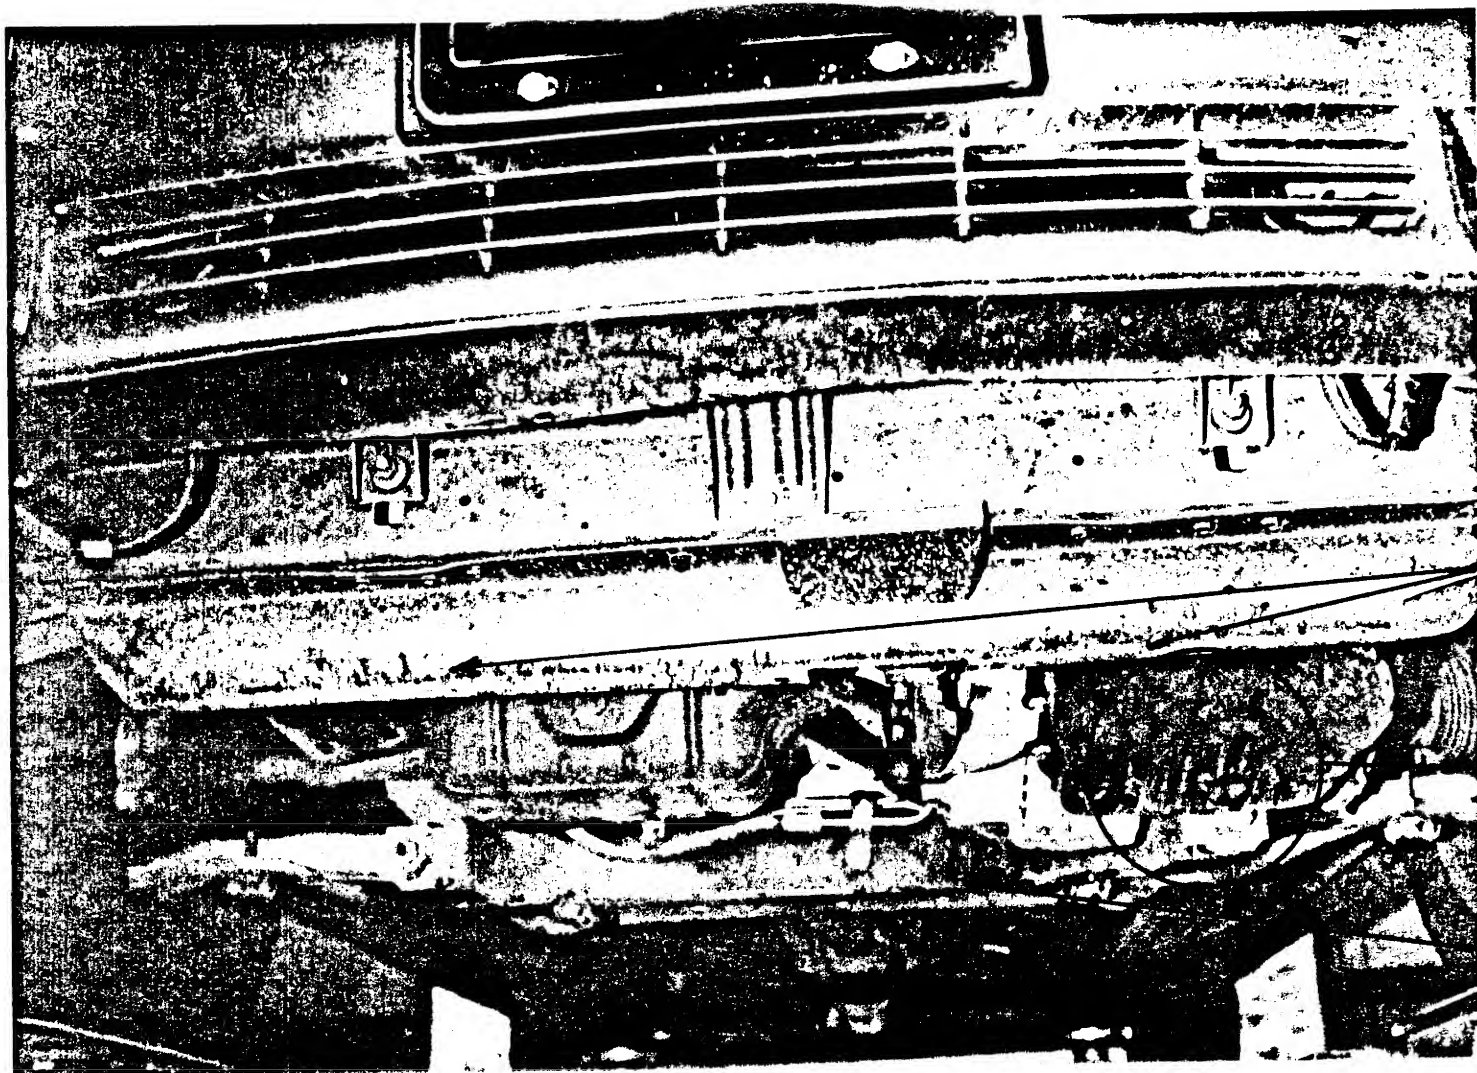
Abrasions to
splash shield

Abrasions to
transaxle oil
pan

Tissue and hair
deposit, appears
to be recent

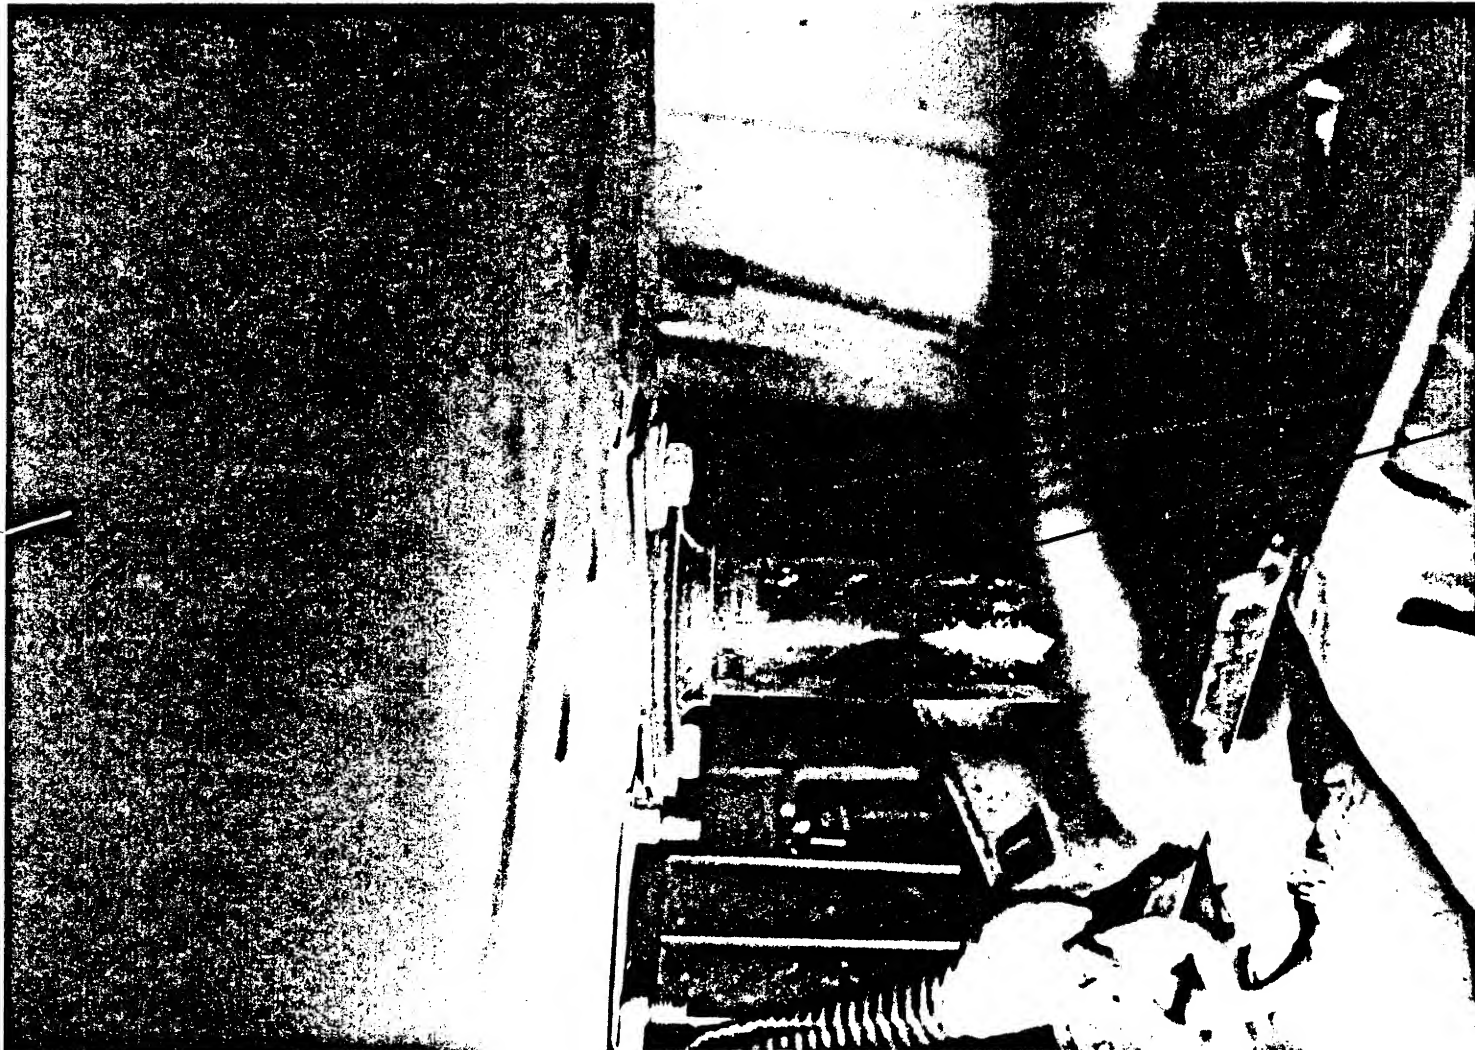
Right front bumper
EAD stroked 7/16",
returned to orig-
inal position

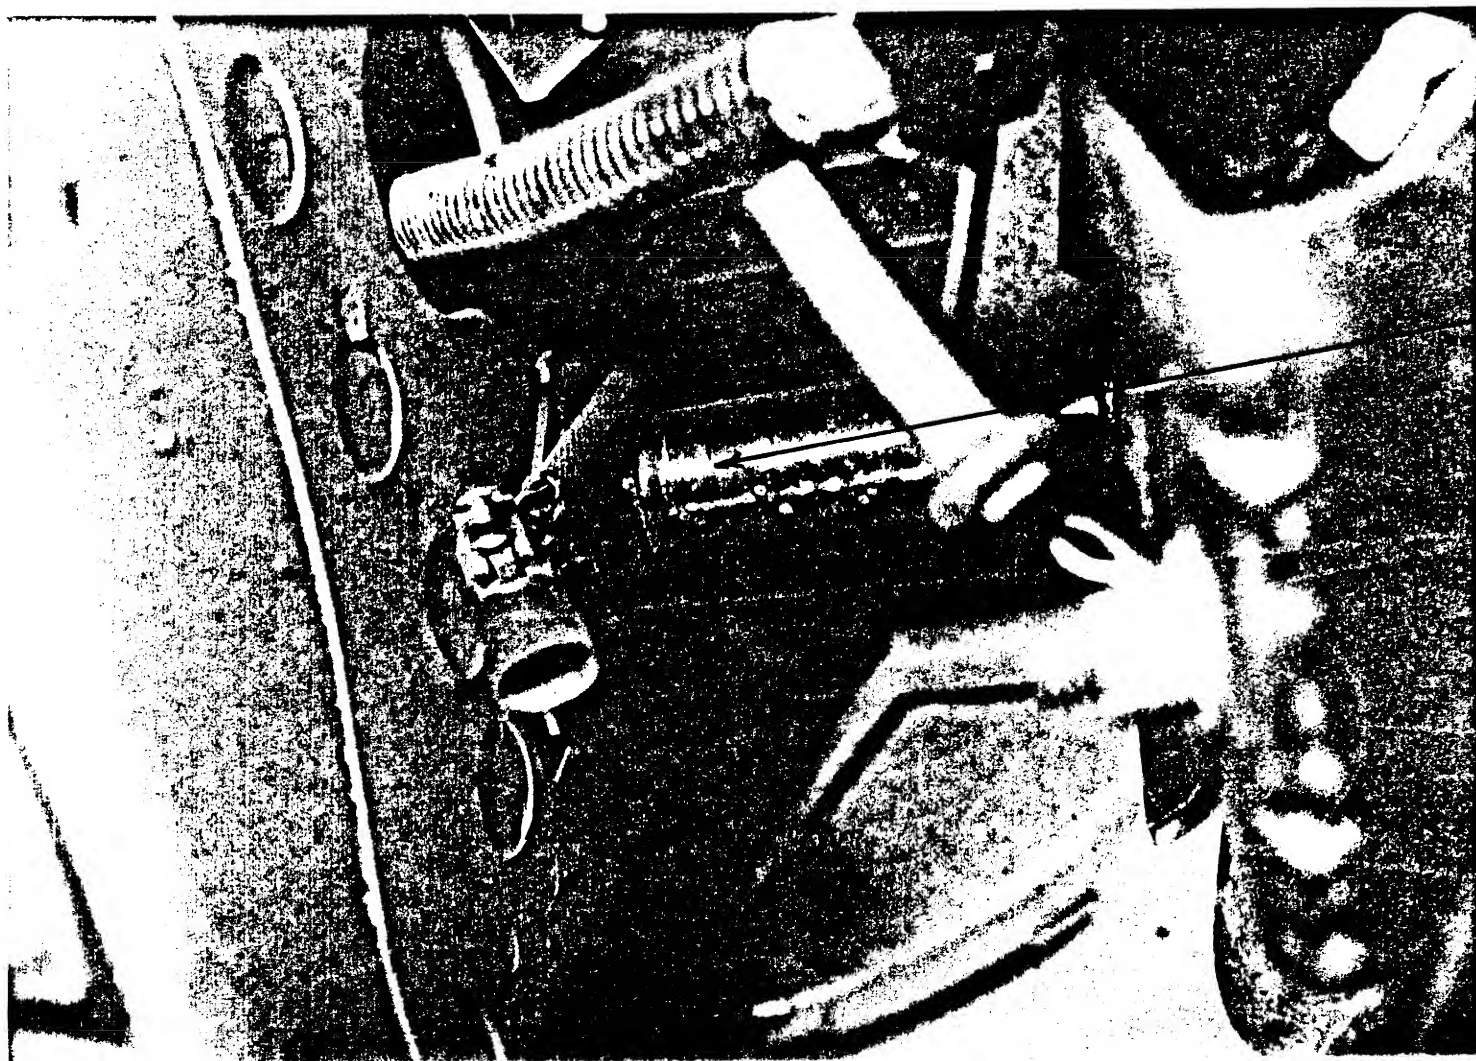
Left front bumper
EAD stroked .25",
returned to
original position
